# When Fire Destroys

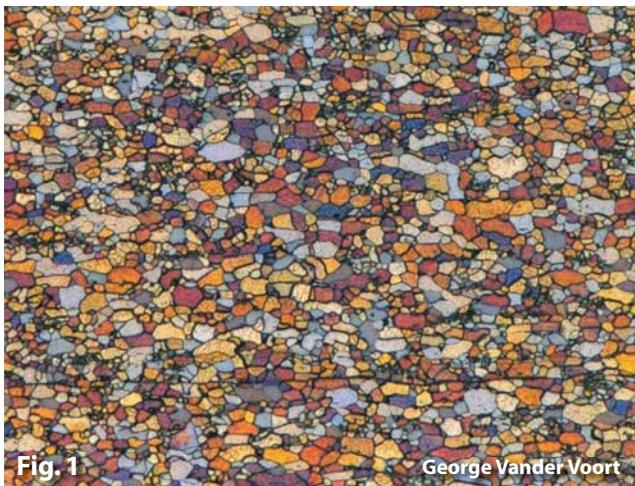
Fig. 1

Figure 1 shows an equiaxed, fine-grained structure of a plate with minimal heat effects. It exhibits the typical structure of hot-rolled, low-carbon sheet steel. In contrast, Fig. 2 shows the struc-

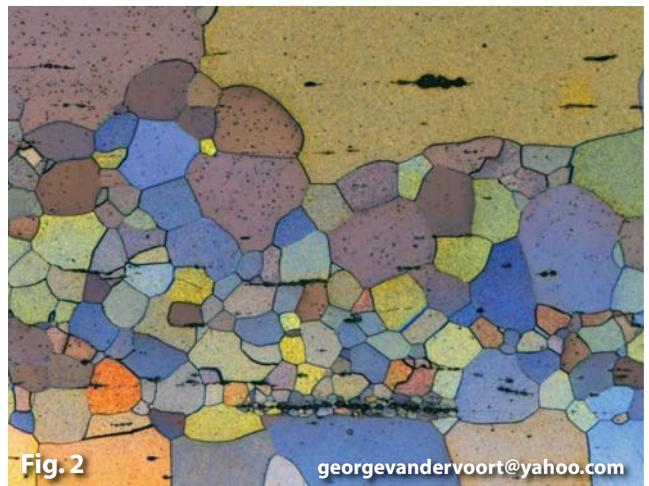
ture of the same plates that had been affected by the heat. These plates were galvanized, and investigation showed that the surface coating of zinc had melted. This means that the temperature exposure was at least 790°F, the melting point of zinc. The coarse, bimodal microstructure shown in Fig. 2 would be typical of secondary recrystallization, which indicates a temperature exposure of 1750-1950°F.

massive cementite particles. These formed after the temperature of the fire dropped below 1340°F when the carbon that had dissolved in the austenite precipitated. Numerous voids were associated with these massive carbides. The voids, massive carbides and coarse grain size would significantly compromise the properties of the gusset plates.

ground up because of what the metal was able to reveal to the trained eye. To the unenlightened, the plates and rafters appeared to have gotten “a little hot,” but since they were still intact, the insurer wanted to cut his losses and reuse some of the heat-affected materials. The skilled metallographer was able to get the metal to say something no human could have.
