# **Metallographic Examination of Heavily Eroded Structural Steel from World Trade Center Buildings 1, 2 and 7**

Steel samples from Buildings 1, 2 and 7 of the World Trade Center were collected during the Federal Emergency Management Agency forensic investigation shortly after the September 11, 2001 incident. Macroscopically, the steel samples supplied exhibited severe “erosion” with plate thickness varying from 12.7mm to a total loss of metal in many areas. Also, some localized plastic deformation was observed. A determination of the cause of this unexpected erosion and an estimate of the maximum temperature that this steel likely experienced are the subjects of this paper.

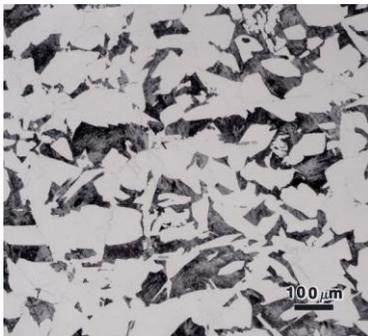
FIGURE 1 (left) Ferrite-pearlite microstructure of an unaffected A36 beam area (nital etch).

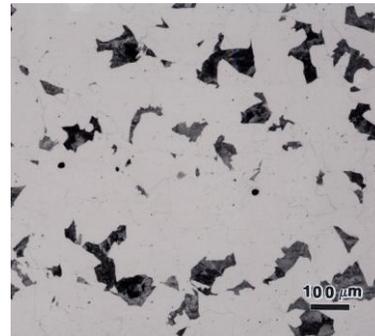
FIGURE 2 (right) Ferrite-pearlite structure of an unaffected HSLA column area (picral etch).

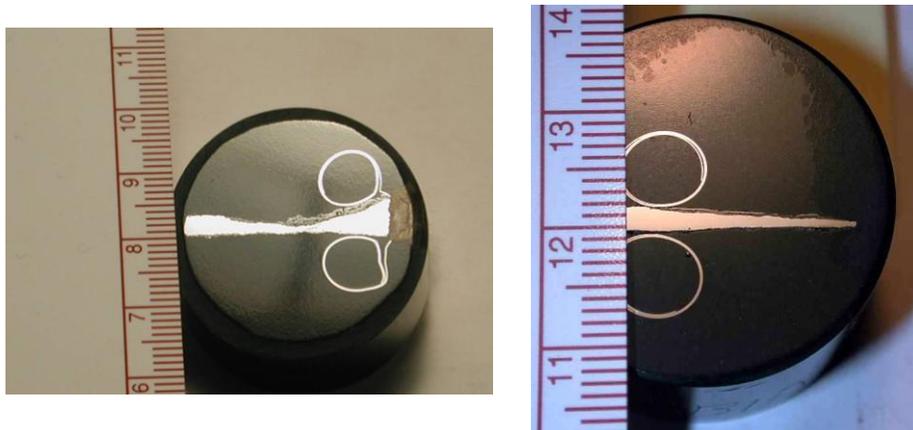
FIGURE 3 Examples of the severe loss of section thickness in the A36 beam (left) and HSLA column sections.

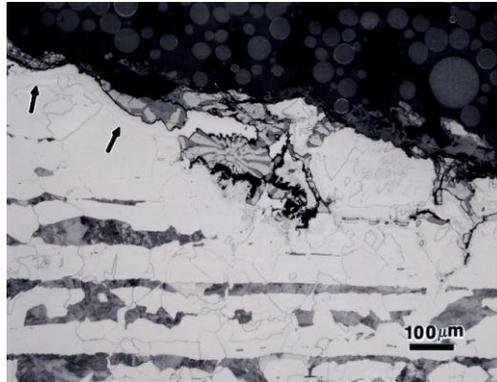
FIGURE 4 Near-surface transformations in the A36 beam: intergranular penetration of the liquid eutectic of FeO and FeS, subsurface decarburization and dissolution of the pearlite (nital etch).

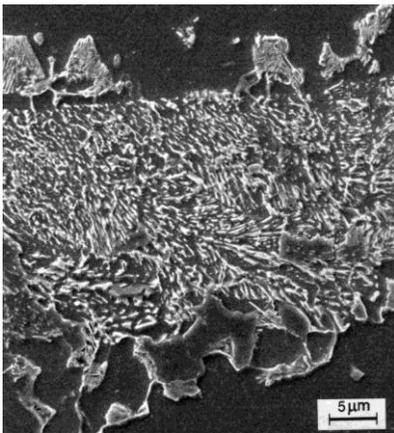
conversion from ferrite to austenite on heating followed by transformation back to pearlite and ferrite on cooling. Typical examples of these transformations are presented in Fig. 5 and Fig. 6 from pearlite banded regions near the bottom of Fig. 4. In Fig. 5 the  $\text{Fe}_3\text{C}$  in the pearlite had started to spheroidize. Also, some pearlite bands have areas where a re-austenitization had occurred and new finer grained regions of pearlite and ferrite formed on cooling as shown in Fig. 6. These observations suggest that the steel in this region had experienced temperatures in the range of 550 to 850 °C.

FIGURE 5 (left) SEM view of the start of spheroidization of lamellar cementite in the A36 steel beam (nital etch).

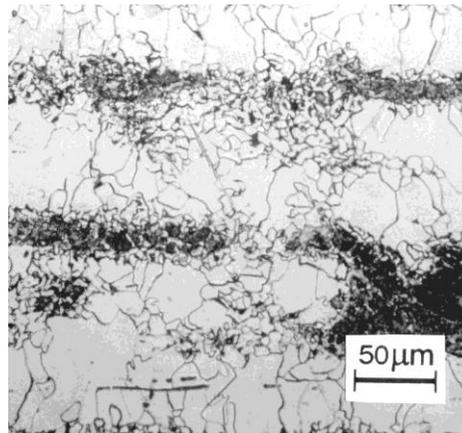
FIGURE 6 (right) Recrystallization of ferrite in areas where the pearlite has been partially dissolved (nital etch).

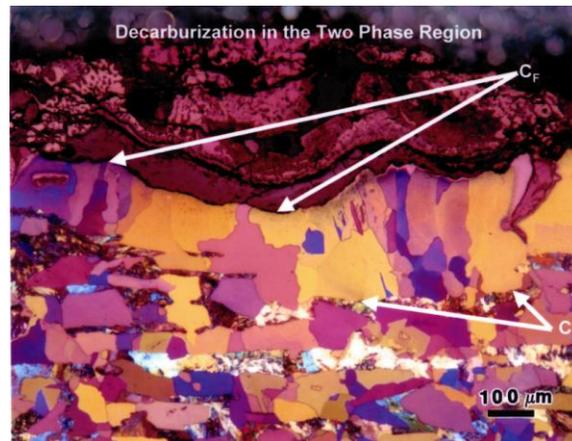
FIGURE 7 Color micrograph showing the growth of columnar ferrite grains beneath the oxidized surface (nital/Beraha's reagent).

At higher temperatures, in the ferrite + austenite phase field region, the chemical reaction rate of carbon loss to the atmosphere increases in addition to the phase transformations. Substantial decarburization can occur in this two-phase region and result in a columnar ferrite grain morphology under the scale on the steel. An example of this microstructure is shown in Fig. 7. Columnar geometry ferrite grains form in this steel as a result of loss of carbon and grain growth under a fixed compositional equilibrium requirement. This transformation likely occurred in the range of 750 to 900 °C. Toward the right side of Fig. 7 a liquid penetration into the steel had occurred when the steel was hot and transformed on cooling to the eutectic mixture of iron oxide and iron sulfide [2]. If these phases are pure FeO and pure FeS, the eutectic temperature is 940 °C [3]. However, incorporation of other elements into the liquid would likely lower the eutectic temperature.

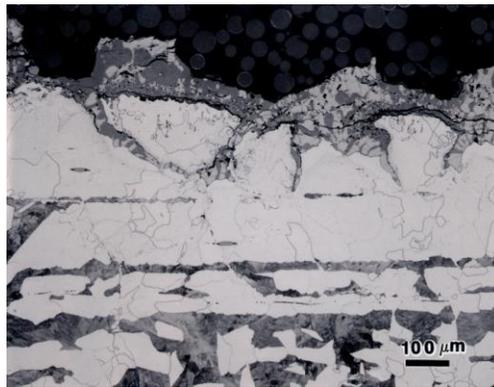
At 940 °C and higher, iron, sulfur and oxygen form a liquid (possibly a sulfate) that penetrates into the iron oxide grain boundaries forming a mixture which dissolves the iron oxide forming a semi-solid with the liquid at the eutectic composition. The semi-solid region is composed of nearly spherical solid iron oxide particles dissolving into the sulfur rich liquid. This is shown in Fig. 8.

The transformed microstructure from the section of the steel beam shown in Fig. 8 shows that the steel had reached a temperature at which it was fully austenitic and had undergone substantial grain growth. The severe erosion observed is a result of sulfidation caused by liquid penetration into the austenite grain boundaries resulting in large grain pullout of material due to a

FIGURE 8 Example of the oxide-sulfide scale and grain-boundary penetration (nital etch).

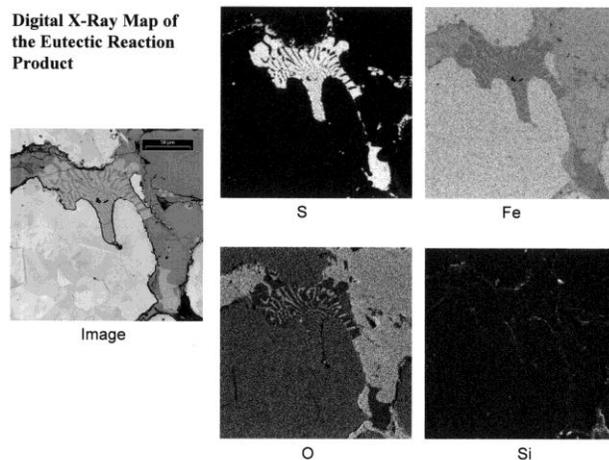
liquid intergranular attack. This liquid transforms isothermally to a two-phase eutectic product on cool-down. Digital x-ray maps for the distribution of iron, oxygen and sulfur in the eutectic reaction region are shown in Fig. 9. Sulfidation in the solid state into the austenite grains occurs much slower and is observed on cooling as a gradient of precipitated sulfides and oxides or oxidized sulfides with many of these particles containing silicon. The oxide scale in Fig. 8 is a multi-phase mixture that occurred on cooling. It can contain different mixtures of retained wustite ( $\text{FeO}$ ), magnetite ( $\text{Fe}_3\text{O}_4$ ) and some hematite ( $\text{Fe}_2\text{O}_3$ ) depending on cooling rate effects. The amount of liquid and solid formed in the semi-solid region as well as the multi-phase oxide mixture observed suggests a maximum steel temperature near  $950\text{ }^\circ\text{C}$ .

FIGURE 9 SEM image and x-ray elemental maps for S, Fe, O and Si.

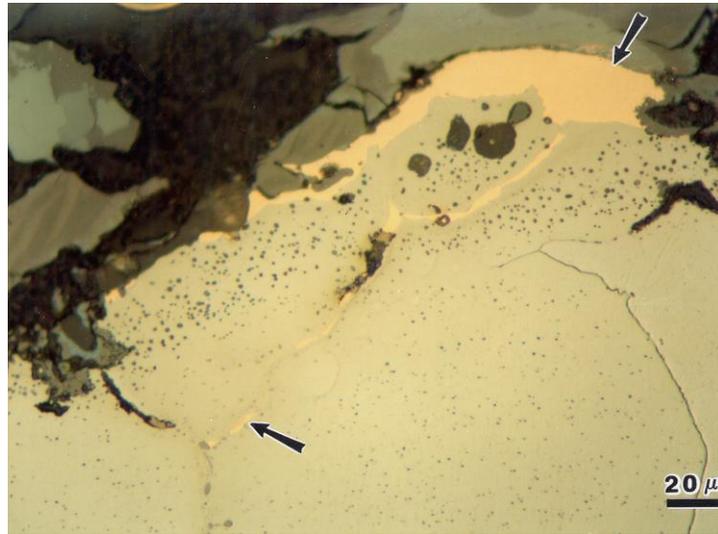
FIGURE 10 Example of the attacked surface of the HSLA column (not etched) showing copper at the steel-scale interface and in the grain boundaries with substantial sub-surface oxide/sulfide precipitation.

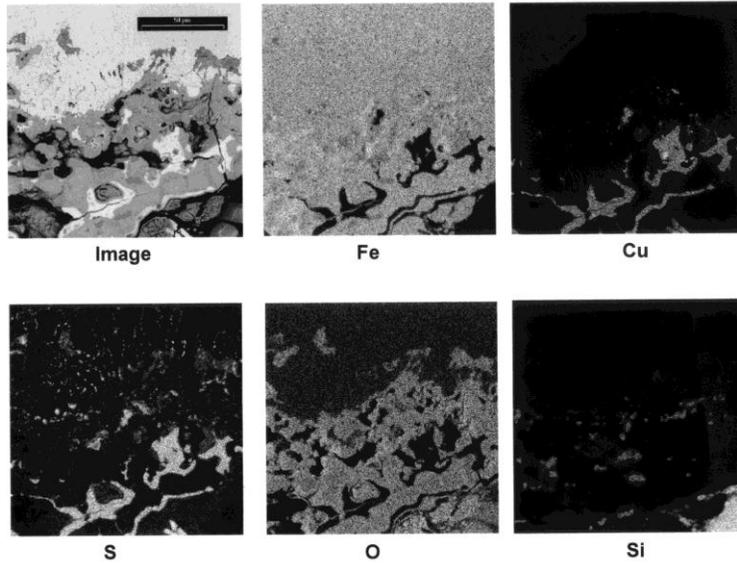
A digital x-ray map of the distribution of major elements through the scale and into the steel is shown in Fig. 11. Sulfur penetration into the oxide scale reacts to form iron sulfide and copper sulfide and a fluxing reaction occurs resulting in sulfur penetration into the steel forming predominantly manganese sulfides in many of the prior ferritic grain boundaries on cooling. It is much more difficult to detect liquid formation in these boundaries prior to cooling

FIGURE 11 SEM image and x-ray elemental scans for Fe, Cu, S, O and Si at the affected surface of the HSLA column.

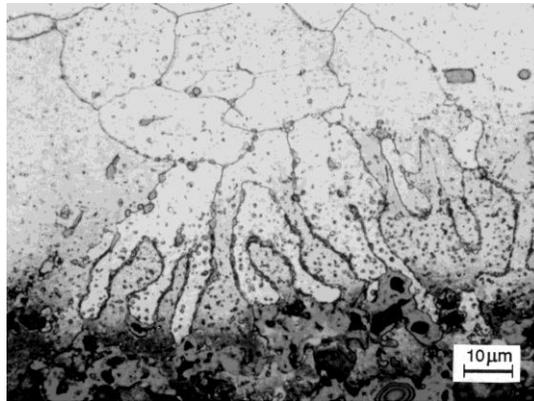
and the additions of copper and silicon complicate the formation of a simple eutectic product. However, the etching response at the grain boundaries of the steel and the formation of a columnar-grained geometry, suggests a thin film liquid corrosive penetration into the boundaries as shown in Fig. 12. More research is necessary to clarify the sulfidation reactions that occur in this HSLA steel.

FIGURE 12 Example of grain-boundary decoration by the eutectic attack in the HSLA column material (nital etch).

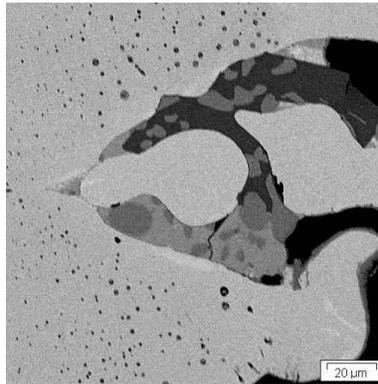
The results of a laboratory heating experiment at 1100 °C for 12 hours where an iron sulfide (FeS) powder was placed on ground and cleaned A36 steel surface prior to heating is presented in Fig.13. The microstructure that developed showed oxidation, sulfidation and eutectic liquid reactions that are quite similar to the microstructure that formed on the WTC 7 steel in the fire. This similarity suggests that when an iron sulfide phase forms on or with the oxide, intergranular attack by a liquid containing Fe, S, and O will occur if the temperature is sufficiently high.

Internal sulfidation and oxidation is also observed in Fig.13. The “dark spots” in the microstructure were found by EDS analysis to contain Mn and S, as well as Si and O. The inward concentration gradient of particles beneath the steel surface indicates a diffusion controlled internal reaction is occurring in this steel. Again, this is similar to the reactions observed in the WTC 7 steel beam. A thermodynamic analysis of the Fe-S-O system with additions of Mn, Si, and Cu is currently underway to determine the conditions that would form these sulfidation and oxidation products.

FIGURE 13 Example of eutectic attack and internal oxidation/sulfidation in the HSLA column material at the surface.
